# Using post-tensioning with the Sika<sup>®</sup> CarboStress System to allow the Removal of Walls

## A Case Study

# Removing Walls to increase the usable Area with post-tensioned CFRP at the Hohenems Agricultural College, Austria

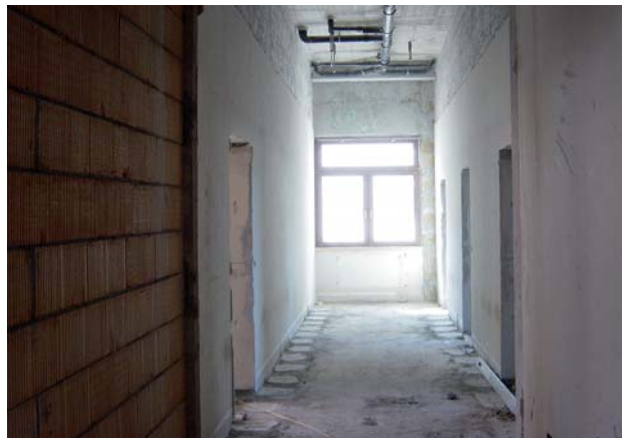
*The two walls left and right of the window had to be removed*

To obtain a more spacious layout, two walls were removed from the ground floor of the existing building. As a result of proposals made by the contractor, the traditional solution originally planned by the structural engineer was changed in favour of a more efficient alternative using **Sika® CarboDur®**, post-tensioned CFRP (carbon fibre reinforced plastic) tendons. The alterations at Hohenems Agricultural College also included structural strengthening of several floor slabs with untensioned **Sika® CarboDur® CFRP** plates.

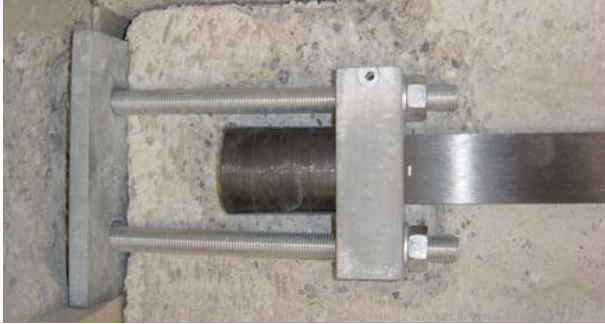
End anchor in the building isolation joint

On the inside, the steel base plates for the fixed end anchors (20 mm thick) were staggered along a building isolation joint, which had the advantage that no drilling was required. The base plates on the tensioning side were staggered along the outside of the building. Holes with a diameter of 30 mm were drilled to pass the threaded anchoring bolts through the concrete wall.

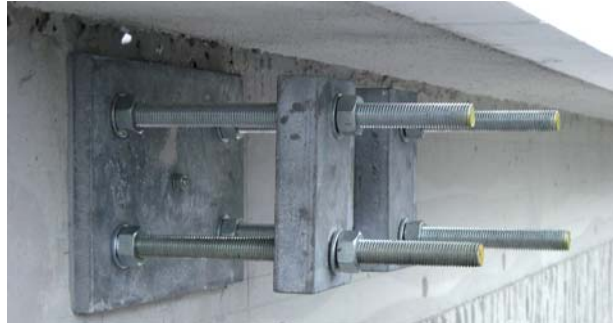
End anchor on the outside of the building

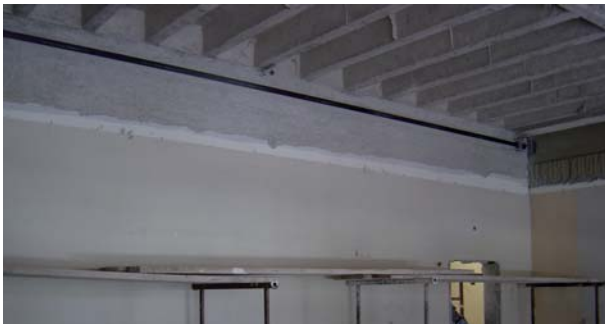
Room A during post-tensioning works

When the base plates had been fixed and bonded, the tensioning works were carried out. To prevent cracking on the upper floors, the 4 CFRP tendons had to be tensioned to 200 kN.

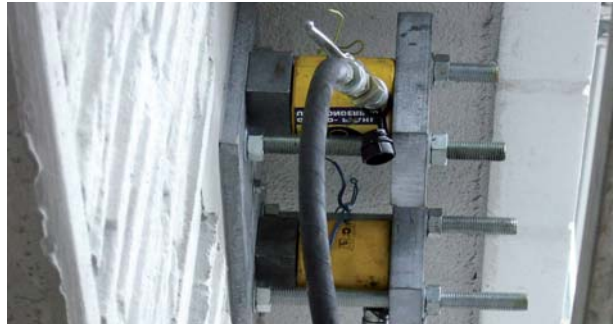
Post-tensioning jacks in operation

On each downstand beam, the tensioning forces had to be applied to both CFRP plates simultaneously. This necessitated working with two jacks to tension both plates at the same time. The selected tensioning force of 200 kN and the plate length of 8.87 m gave a tensioning path of 67 mm.

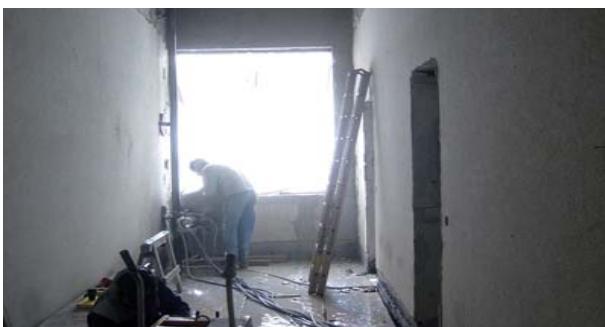
Cutting the vertical slots

Staggered positioning of the steel supports on the outside of the beams took place after the **Sikadur®-30** bonding adhesive had cured. Vertical slots were cut in the reinforced concrete walls and a concrete section was removed. The steel sections were then inserted, grouted and sealed with **SikaGrout®** and also anchored vertically.

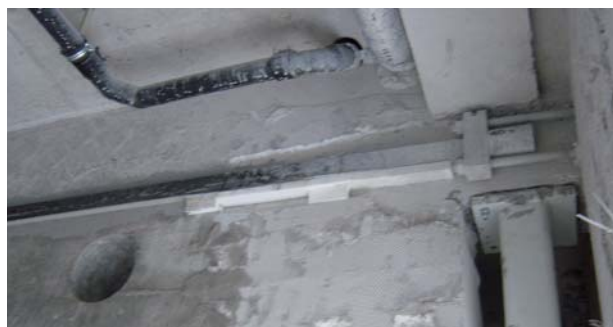
Steel support installed on the outside wall

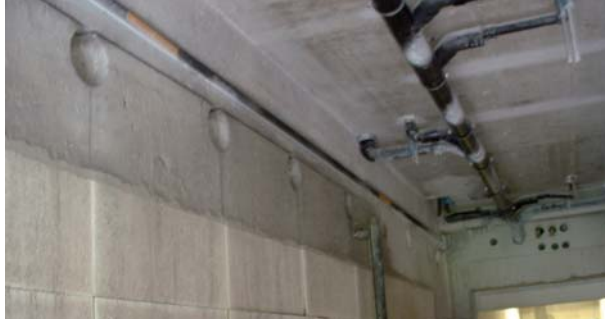
Wall after cutting into 1 m<sup>2</sup> sections

To enable the existing walls to be removed from the building, it was necessary to cut them into sections about 1 m<sup>2</sup> in size. To do this, cores with a diameter of 20 cm were taken at the top and bottom. Access was then possible for the equipment to make the horizontal and vertical cuts.

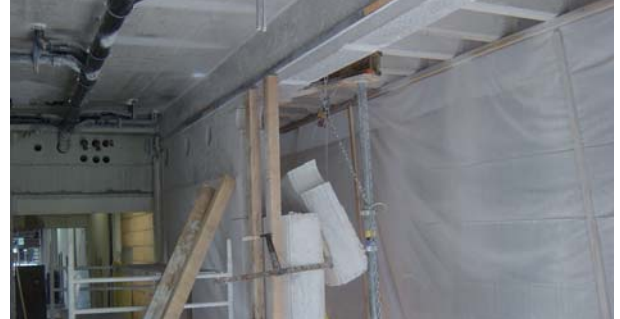
Removing the cut concrete sections

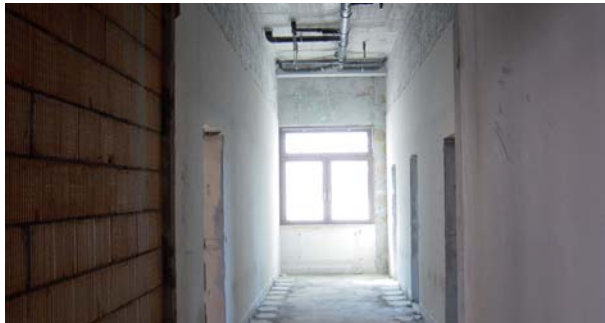
Walls before the start of the works

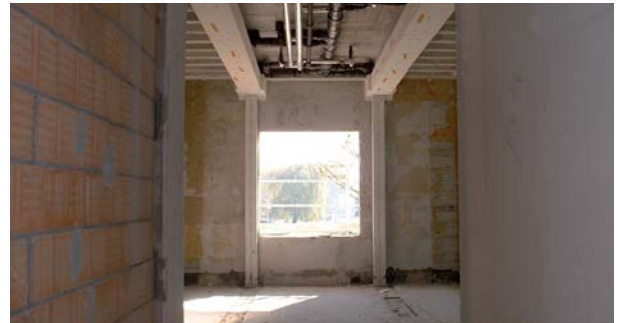
Completion of the works with the walls removed

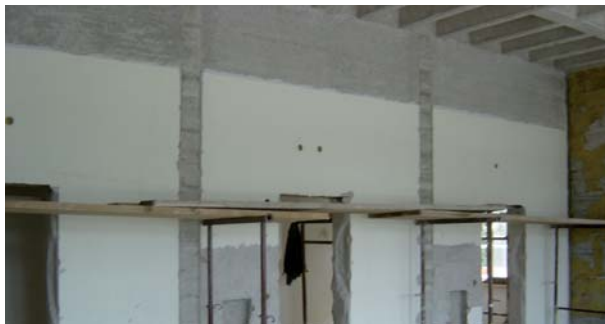
The room before the start of the works

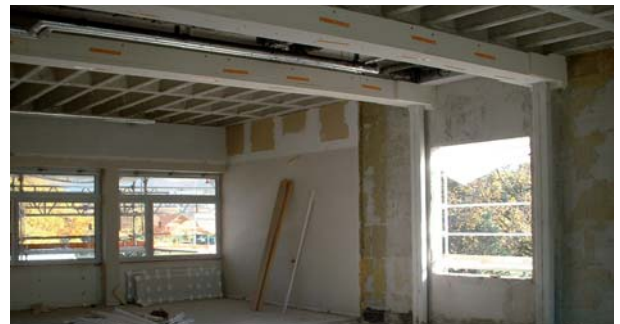
The much enlarged room on completion of works, with a far greater useable area exactly as the client required

The requirements for fire protection were met by the application of 2 layers of 30 mm thick calcium silicate board around the remaining downstand beam. The steel supports were also given a fireproof coating.
