Bridge Strengthening with the  
Sika<sup>®</sup> StressHead Prestressing System

International Case Studies

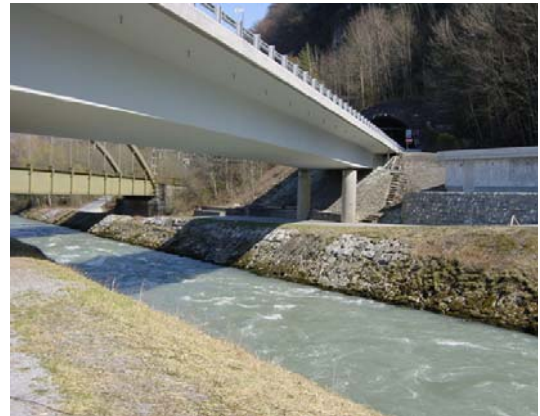
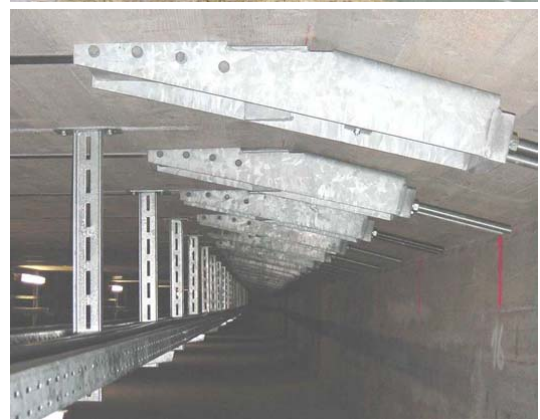
## A3 Escher Canal Bridge, Glarus (Switzerland)

During an inspection in 1964, a crack running the whole length of the bridge was found in the centre of the underside of the deck. This was then continuously monitored by the engineers until a possible solution could be found.

The deck slab was strengthened transversely for positive and negative moments with **Sika® CarboDur® CFRP** plates. The tensioned plates on the underside of the deck slab act as external prestressing. The tensioning force is transferred to the concrete only at the ends of the plates and these were carefully located to achieve the maximum strengthening effect.

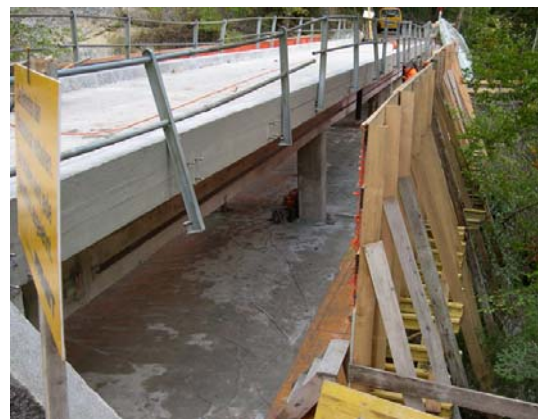
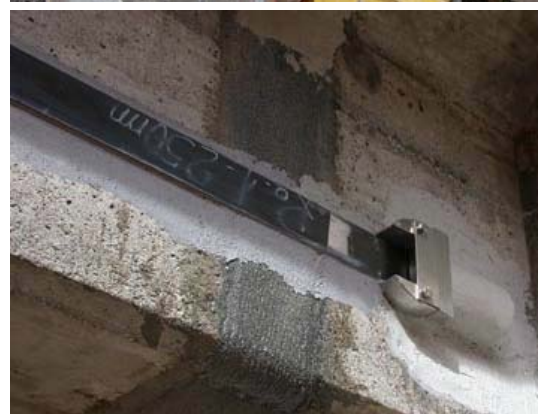
## Hütten Bridge, Werthenstein, Lucerne (Switzerland)

The management of the surrounding forests now required the bridge to carry heavier loads of timber with larger trucks taking up to 40 tons. Neither of the two main bridge beams on the three span bridge could take this new loading and they both had to be strengthened for the increased flexural and shear force loadings.

Both beams were strengthened with prestressed **Sika® CarboDur® CFRP** plates up to 30 metres long on both sides. The end anchorage of the prestressed plates consisted of continuous shear connectors through the beams, which introduced the tensioning forces into the beam. **SikaWrap®** fabric loops were used for the shear strengthening. Slots were first cut vertically in the deck slab so that the loops could completely surround both the tension and compression zones of the beams. The loops were then inserted in several layers and bonded together with **Sikadur® Adhesive**.

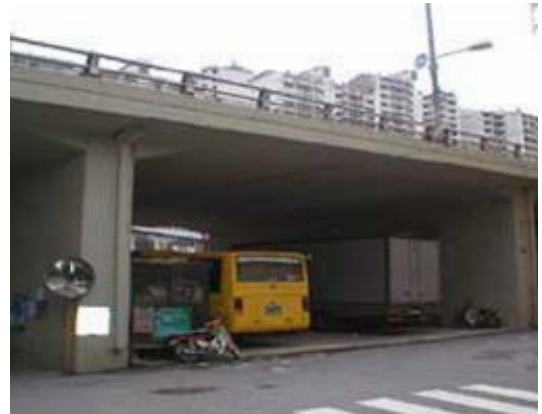
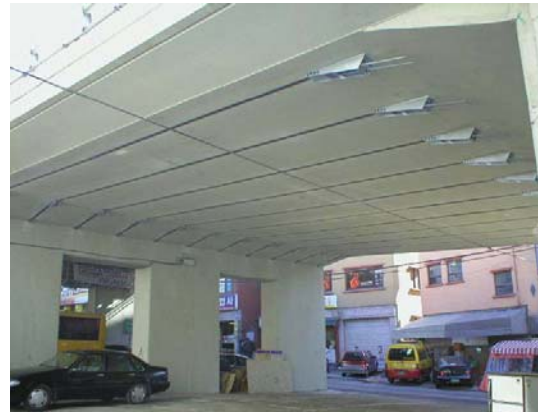
# Sung San Bridge, Seoul (Korea)

The deck slab on the bridge had large transverse cracks in several places. They were as a consequence of ever increasing traffic loads for which the longitudinal reinforcement in the deck slab had not been designed. Strengthening of the tensile resistance underneath was particularly necessary around the abutments and supports. In some cases the end anchorages also had to be located directly in the supports, i.e. in the haunch.

The longitudinal strengthening was achieved with prestressed **Sika® CarboDur® CFRP** plates. The plates were deflected around the haunches by a steel saddle to prevent the plates becoming attached. The end anchorage of the CFRP plate could then be transferred directly to the sloping part of the haunch.

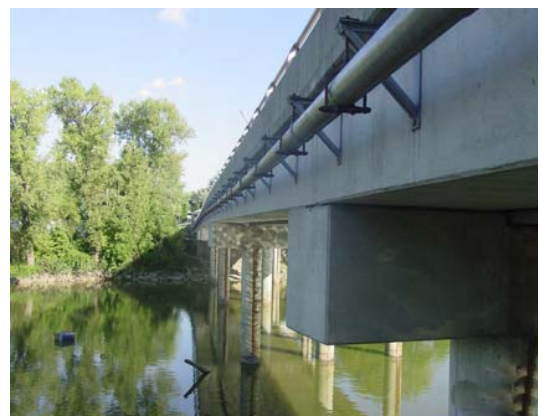
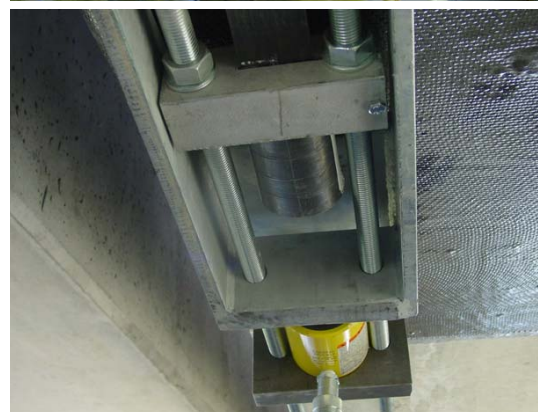
# Clinton & Hopkins Bridges, Ohio (USA)

Leaking drains and a defective drainage system caused corrosion damage to the prestressing wires, requiring the box girders to be strengthened.

The precast box girders had been designed to be very slender and therefore in the end anchorage zones, the concrete was also strengthened locally with **SikaWrap®** fabrics. The prestressed **Sika® CarboDur® CFRP** plates supplemented the main damaged tensile reinforcement and restored the structural strength and integrity of the bridges.

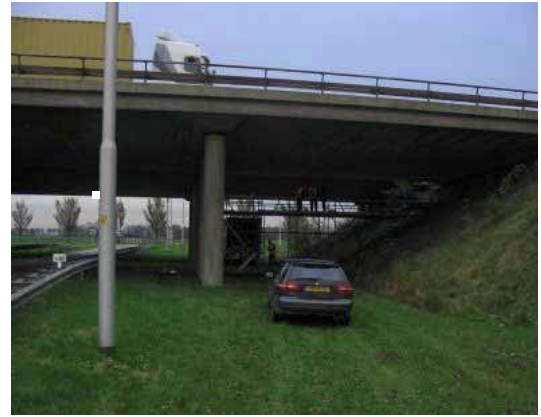
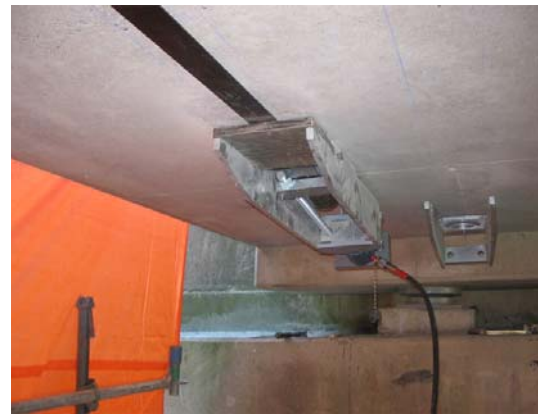
## A7 Bridge Viaduct, Zaandijk (Netherlands)

During routine maintenance work, one of the pretensioning cables at the edge of the west part of the viaduct (traffic direction north to south) was severely damaged. The cable was touched by the drilling equipment for a new rain water drain. The extent of the damage was difficult to assess, but the Rijkswaterstaat (Dutch Ministry of Transport) estimated a potential loss of approximately 50% of pretensioning capacity. The viaduct was therefore closed to traffic above 28 tons in the southerly direction. Heavy traffic was then forced to go the longer way around via Zaandijk.

Two **Sika® StressHead** units, each 8m long and loaded to 220 kN underneath the bridge deck have been installed. Additionally 3 **Sika CarboDur® CFRP** plates were bonded alongside the end anchors.
